List of Classified Structures Page 1 of 3

Bonita Well Windmill

Structure Number: HS03D

Park: Organ Pipe Cactus National Monument

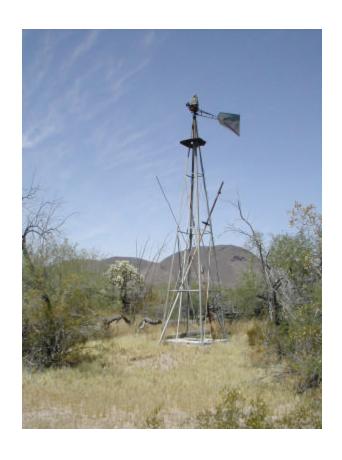
Short Physical Description: Nearly Intact windmill complete w/ pipe from well to trough in corral.

> Aeromotor windmill on metal frame w/ 5'6" sq. base w/ ladder. Blades have fallen to the ground, pipes inside tower are no longer connected top and bottom. Well beneath framed out in concrete, poured out to anchor tower

Long Physical Description: An almost intact windmill complete with pipe leading from the well below it ot

> the trough in the nearby corral. It is an Aeromotor windmill set on a metal Aframe with a 5' 6" square base. Blades have fallen to the ground, pipes within tower are no longer connected top and bottom. The legs of the tower are set in concrete. The well beneath the windmill is framed with concrete.
